DETERMINING THE FLOOD EFFECTS OF UNDOCUMENTED STOPBANKS WITHIN THE WAIMEA FLOODPLAIN

A thesis submitted in partial fulfilment of the requirements for the Degree
of Master in Civil Engineering
University of Canterbury
2019

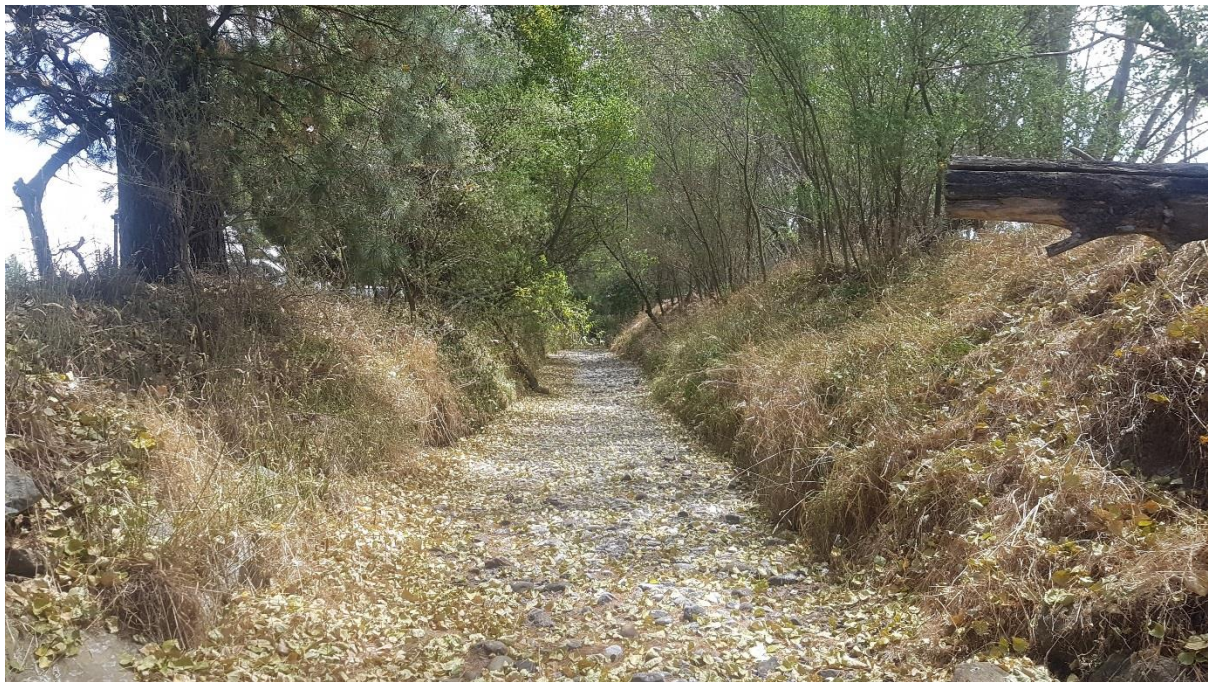
Figure 3.4. Typical West Pitfure stream channel bed section

method may have straightened, widened, and deepened the riverbed along the western section of the Pitfure stopbank, see Figure 3.4. Channel straightening can lead to faster stream flows that can cause further stream bank scour, thus further straightening the channel (CIRIA et al., 2013).

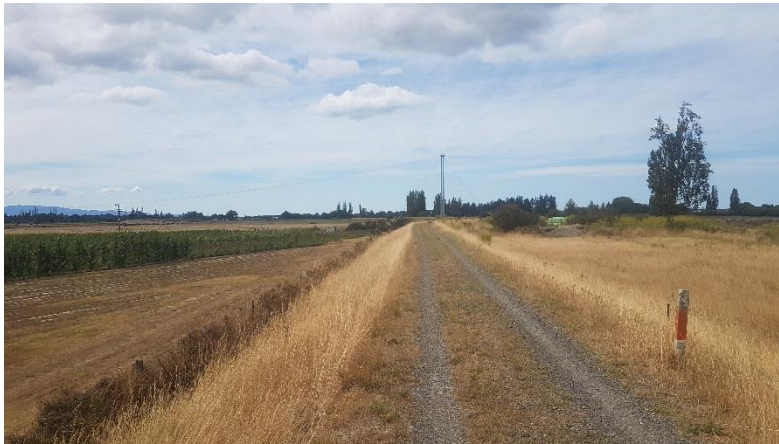
Figure 5.1. Typical cover of a Council stopbank

typical cover is shown in Figure 5.1. It should be noted that there were trees planted at the toes of the stopbank at three locations; at one of these, roots were present on the stopbank crest surface.

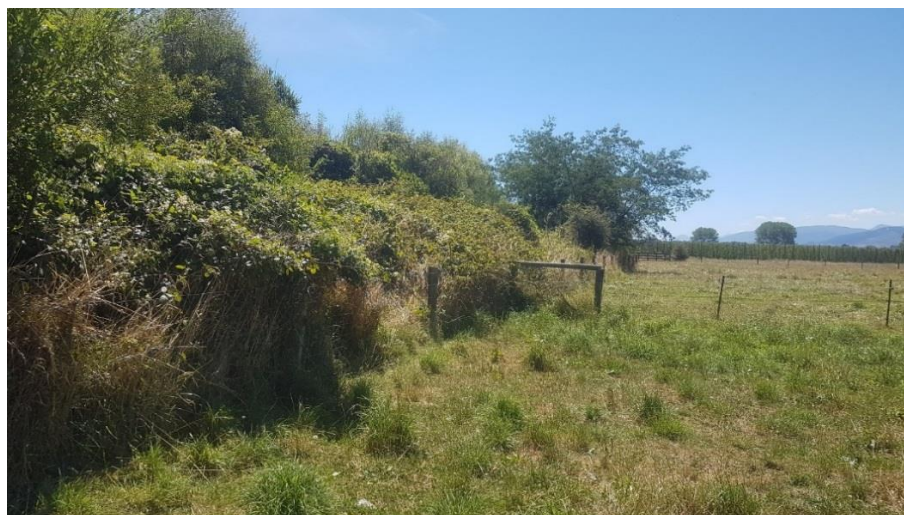
Figure 5.2. Example of brambles along the Main Spring Grove stopbank

To remove the widespread bramble along the undocumented stopbanks would require either digging up the entire surface to remove the roots or first mowing the banks and then spraying herbicides to kill the new shoots. Removal of the roots would require a significant amount of funding and is likely to cause damage to the stopbank. This type of cover has associated issues similar to the trees, discussed in section 5.1.1.

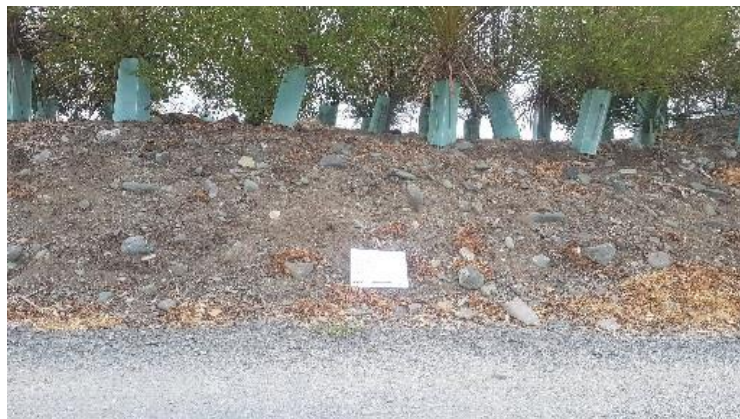
Figure 5.4. Example of newly planted trees along the Wairoa Confluence stopbank

This newly planted wildlife habitat was planted by the TDC Parks and Reserves team as part of fulfilling the second objective of conserving nature and restoring indigenous vegetation with the park. It should be noted that this area runs alongside the Twin Rivers Walkway.

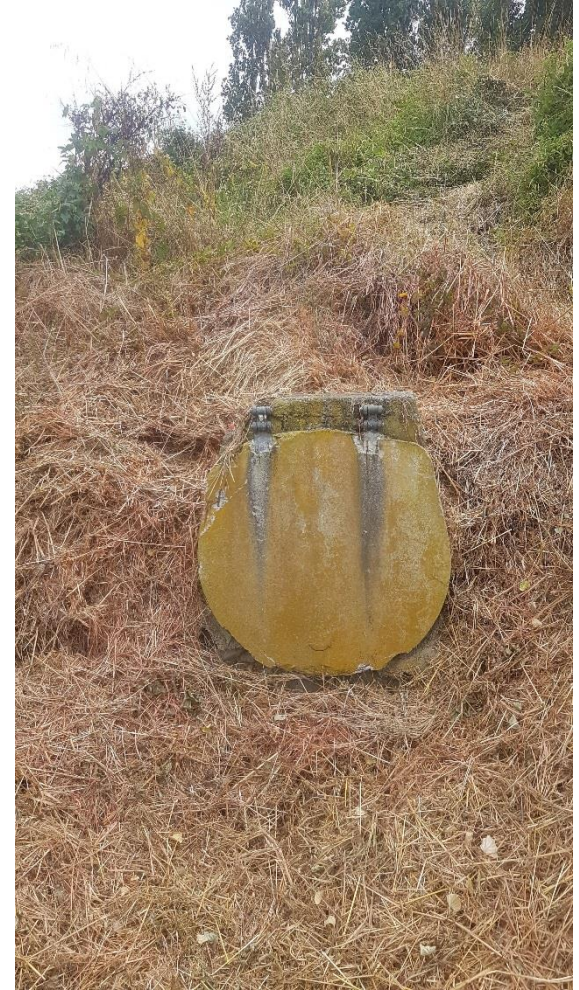
Figure B.10. Conduit at S3

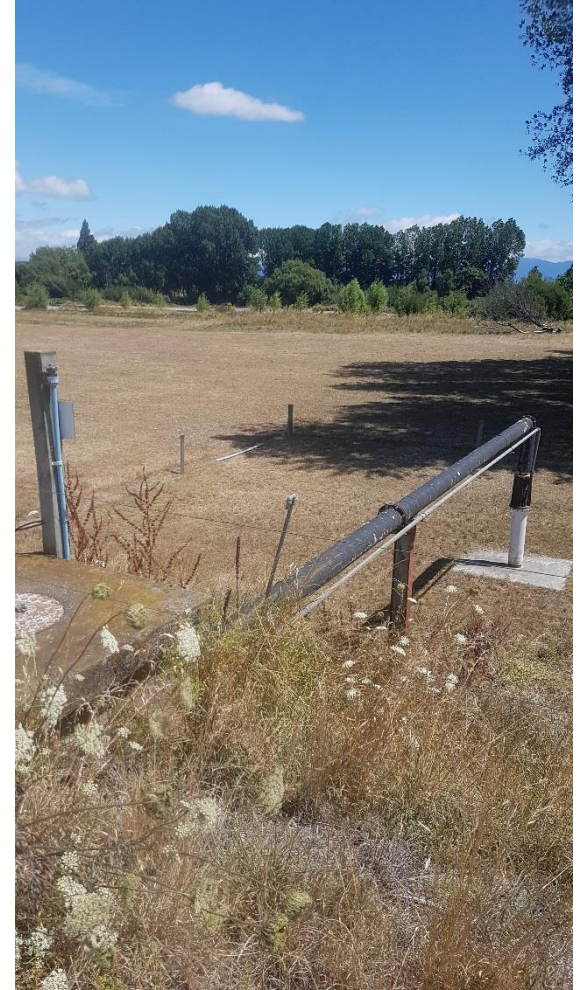
Figure B.14. Pump station at S7

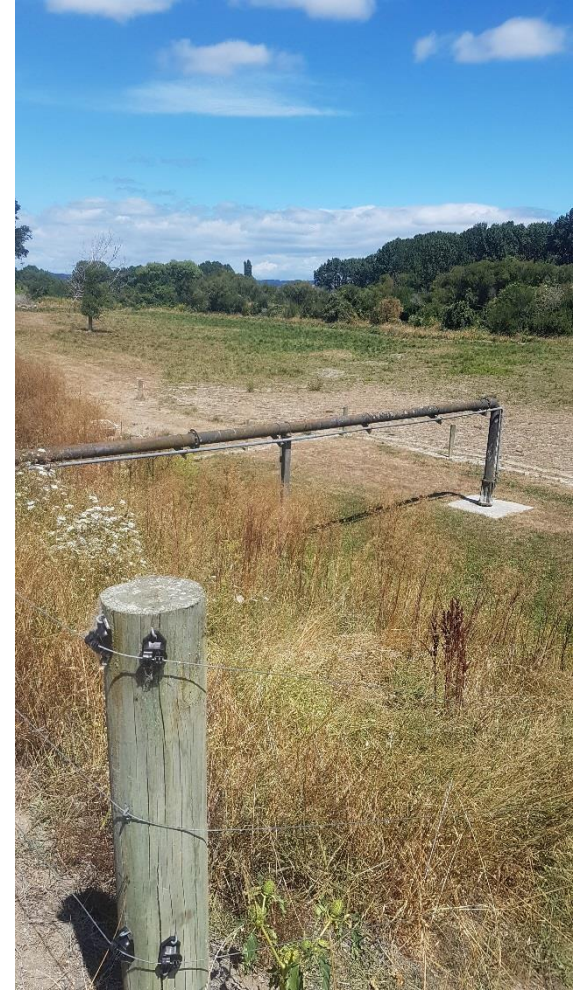
Figure B.17. Pump station at S10

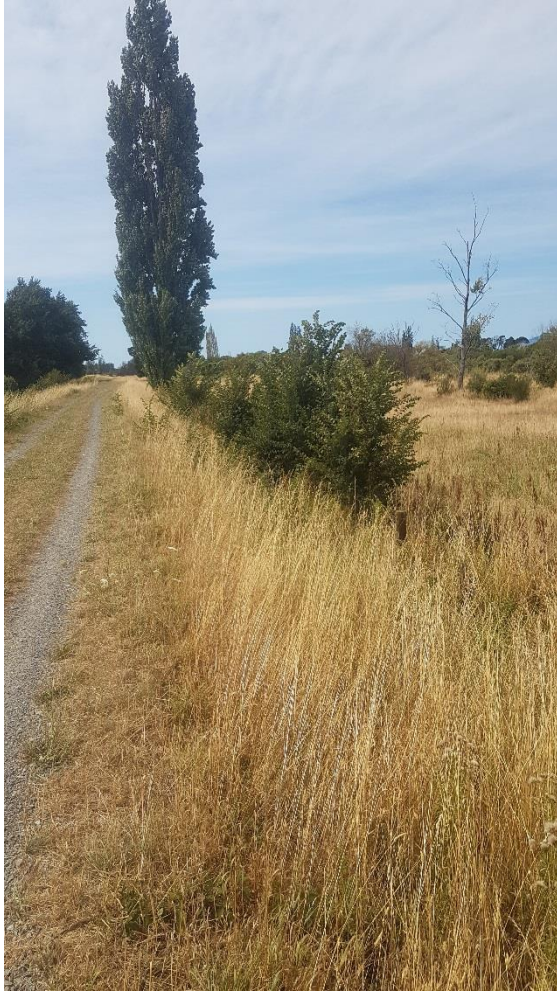
Figure B.20. Tree at T1

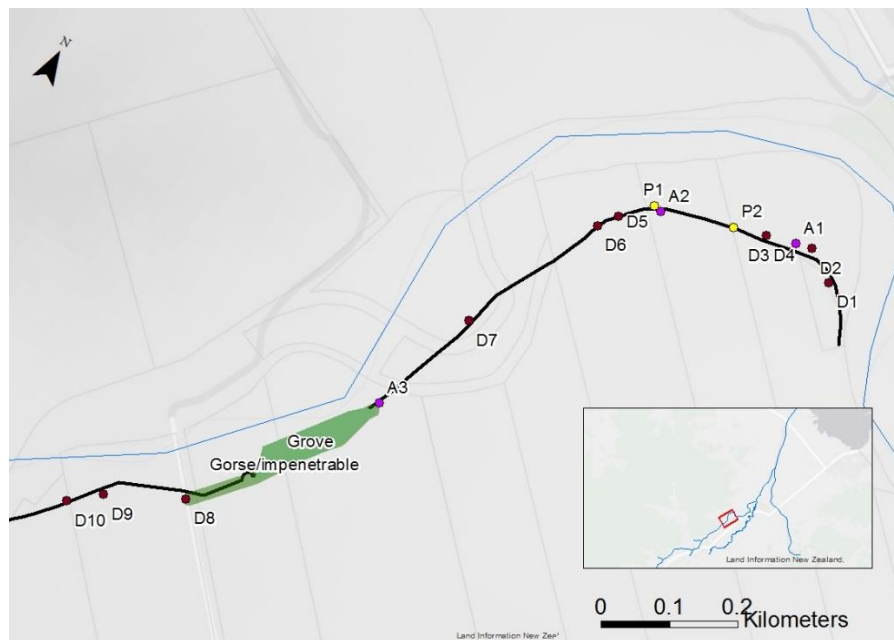
Figure B.24. Downstream MSG features map

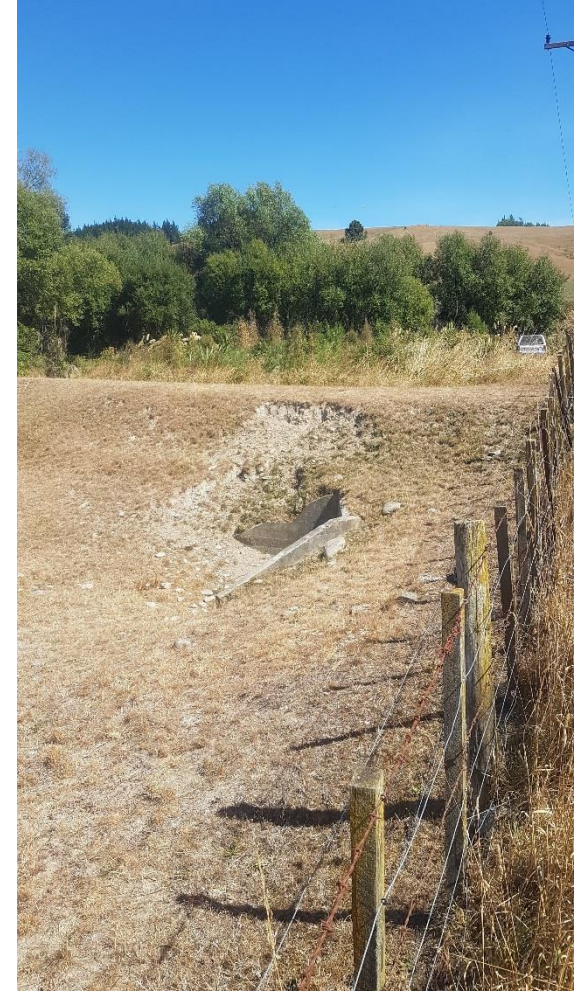
Figure B.36. Exposed fill at D8

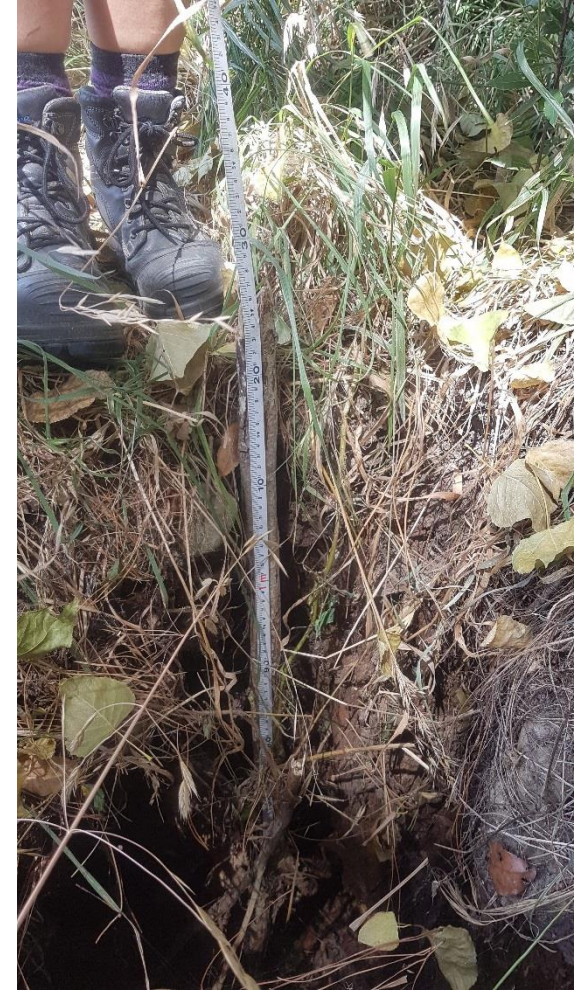
Figure B.50. Void at D3

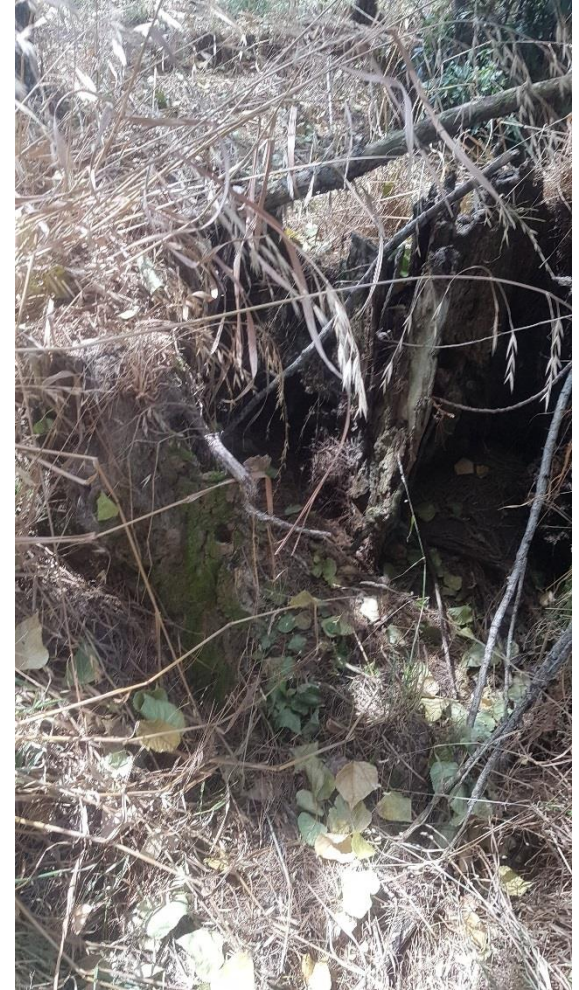
Figure B.53. Void at D6
